Drone potentiale ved drift og vedligehold af store brokonstruktioner, samt anvendelse af kunstig intelligens til skadesregistrering

Storebælt
Sund ≅ Bælt

DANVAK dagen 2019

The Storebælt Link

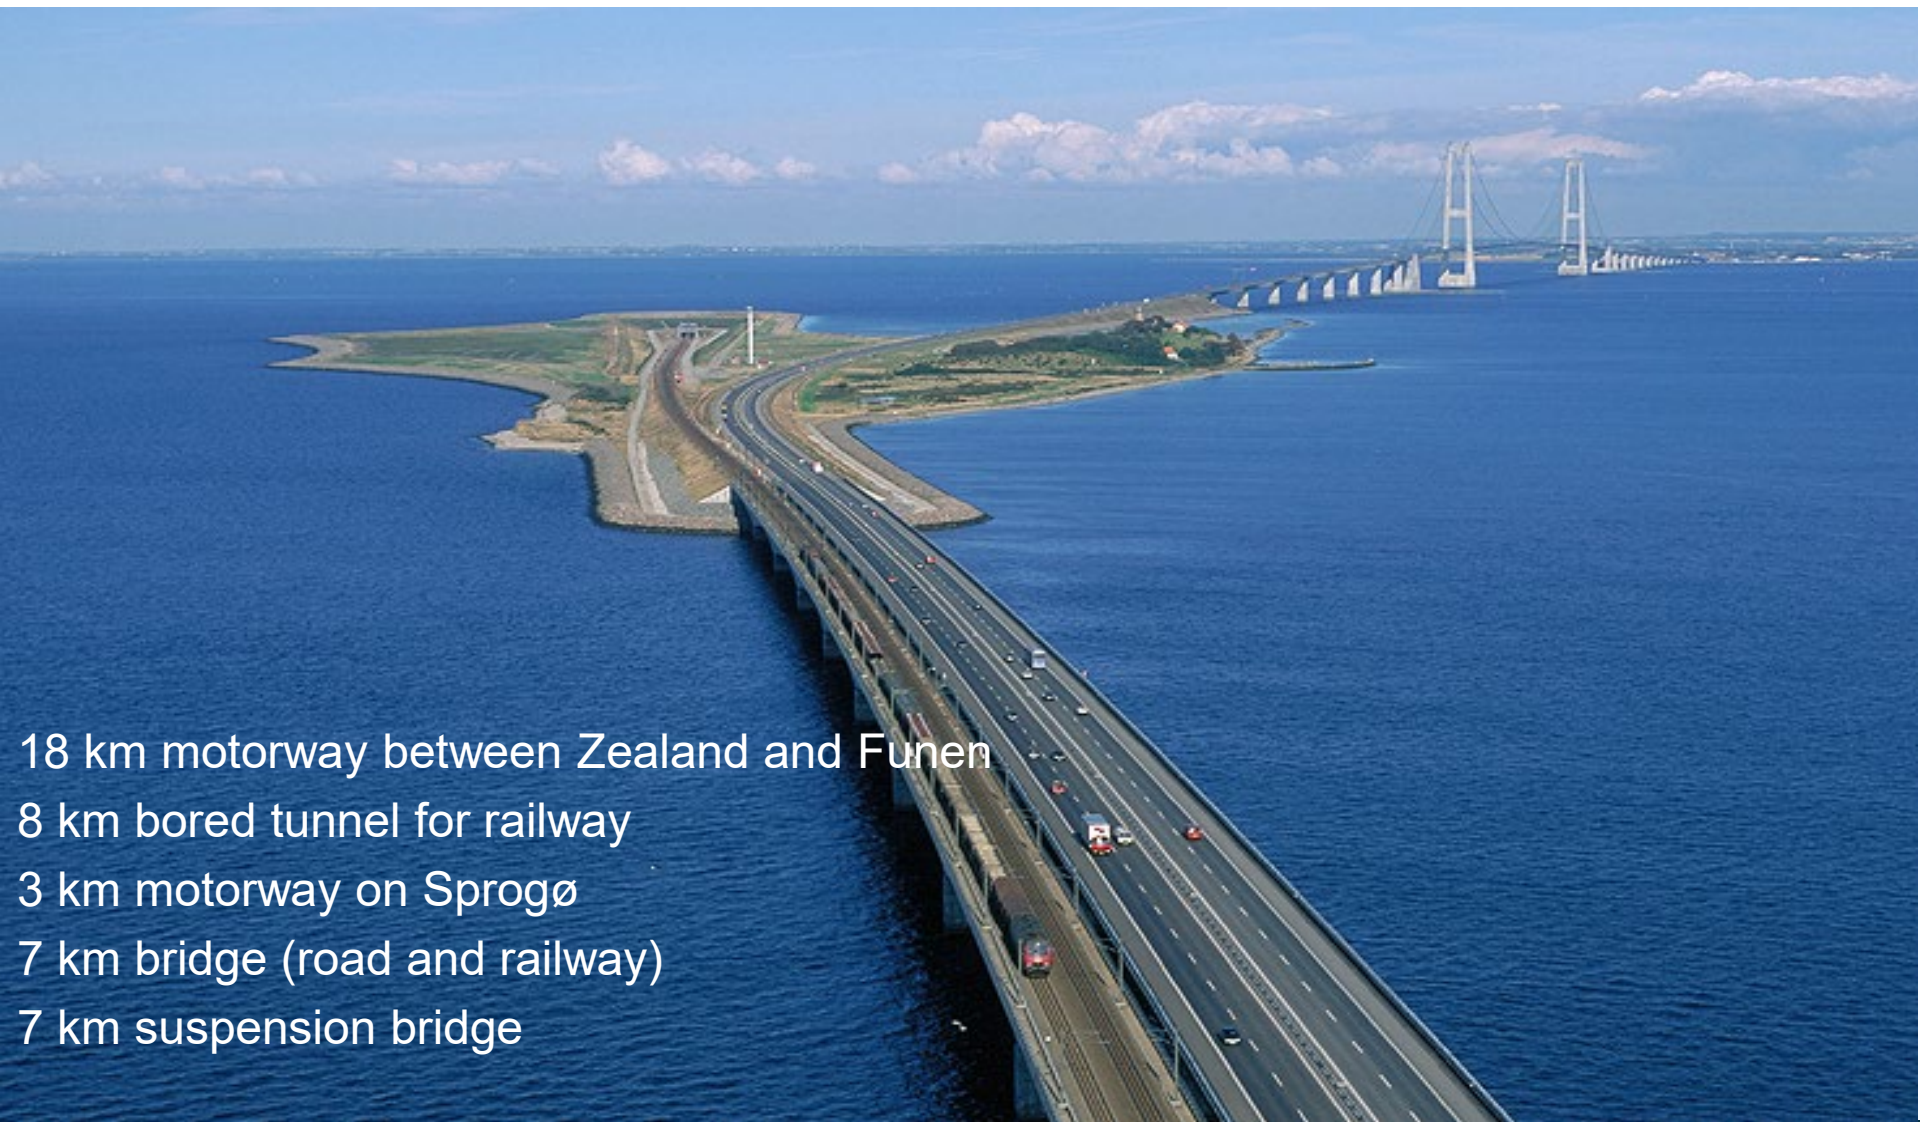
The Storebælt Link

- 18 km motorway between Zealand and Funen
- 8 km bored tunnel for railway
- 3 km motorway on Sprogø
- 7 km bridge (road and railway)
- 7 km suspension bridge

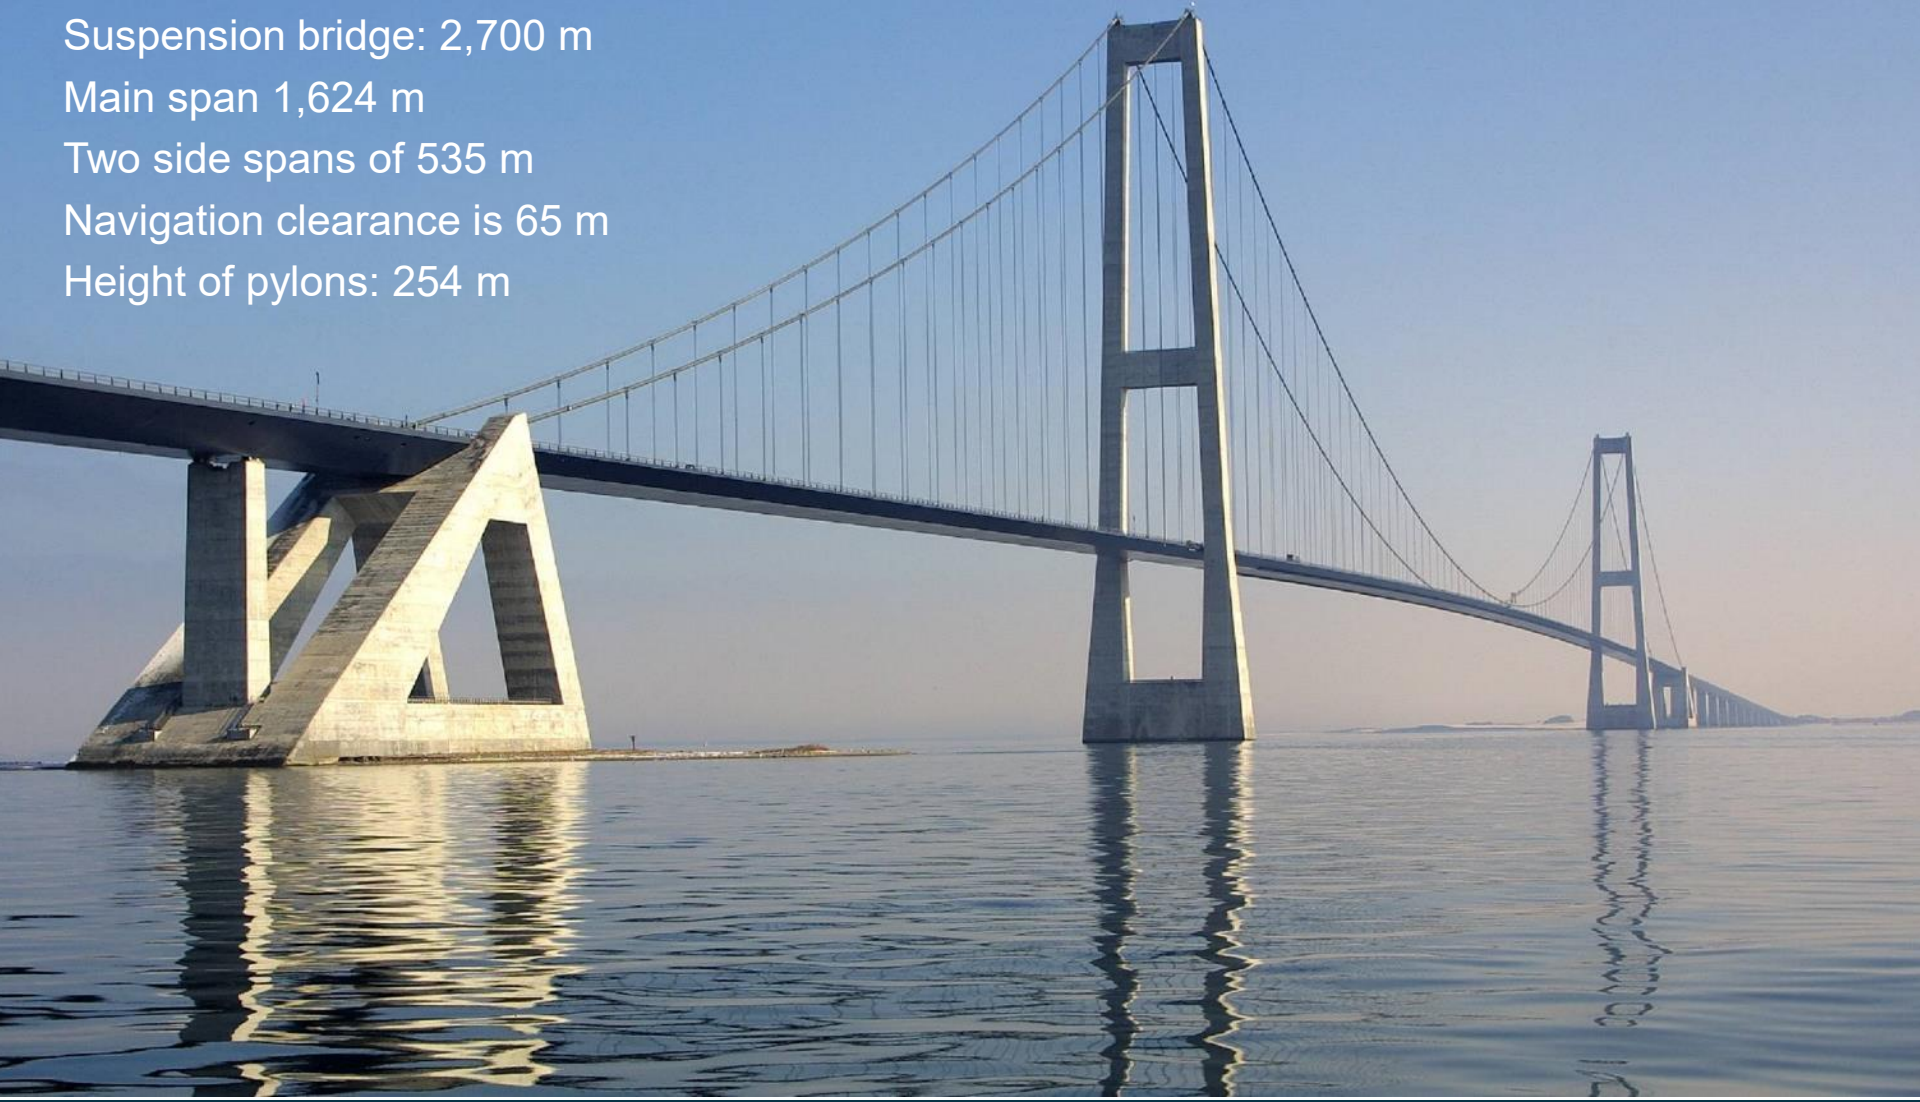
The Storebælt Link

Suspension bridge: 2,700 m

Main span 1,624 m

Two side spans of 535 m

Navigation clearance is 65 m

Height of pylons: 254 m

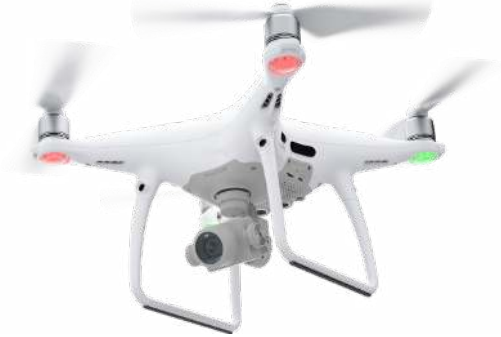
- First Anchor block completed using standard DJI Phantom 4 Pro
- Unable to look up and low GPS accuracy (1-2 meters)

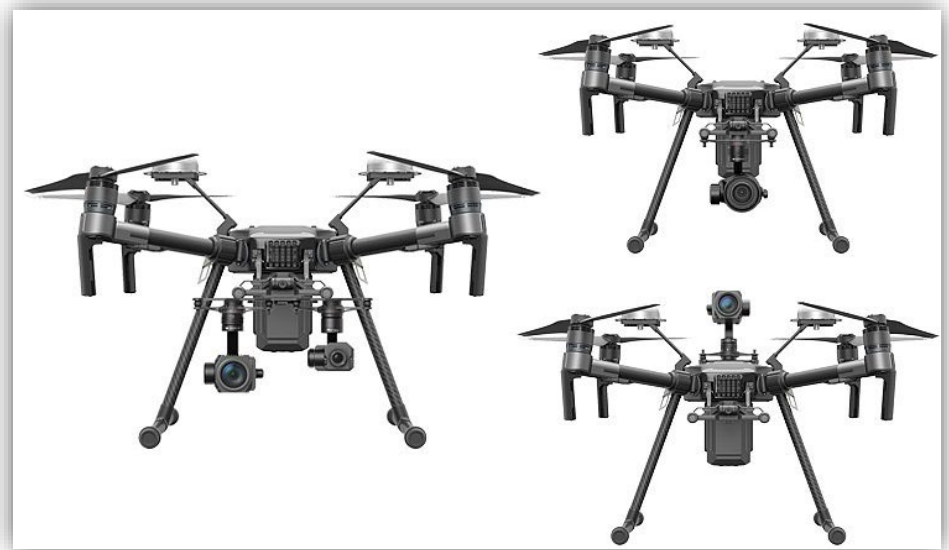
Matrice 210 RTK, ver 2

- Option to mount camera on top and look up underneath the bridge
- better GPS positional accuracy through RTK (15-20 cm)
